15, 0.500 5000	S-	-E-C-R-E-T		25X1
COUNTRY	Poland	REPORT		
SUBJECT  DATE OF INFO.	<ol> <li>Harbor Installations in Wladyslawowo</li> <li>Harbor Installations at Gornoslaski Quay in S</li> </ol>	REQUIREMENT NO.	17 October 1955	25X1
PLACE ACQUIRED		REFERENCES		
DATE ACQUIRED	COURCE EVALUATIONS ARE DEFINITE	This is UNEVALUATED Info		4
	COURCE EVALUATIONS AND THEIRING	VE APPRAISAL LIE STATISTICS IS I	LINAINE.	
		report, with	an attached	25X1(1
sket and	ch, of installations in the a report concerning ship sign	ghtings in Swinoujscie (Sw	inemuende)	
				7
,				_1
			4.	
200				
,				051/4
				25X1
•				
				*
;				
25 YEAR RE-F	PEVIEW/		$R^{-\alpha}$	•
23 TEAR RE-F	·		<b>O</b> ,	
			Y	
	S_E_C	-R-E-T		
<del>_</del>		AIR X FBI AEC		25 <b>X</b> 1
STATE X	ARMY X NAVY # X	(Note: Washington distribution indic	ated by "X"; Field d	
LNICOR	MA <sup>°</sup> TION REPOR	T INFORMAT

Approved For Release 2009/06/12 : CIA-RDP83-00418R001500120001-7 Wladyslawowo

Gornoslaski Quay, Stettin

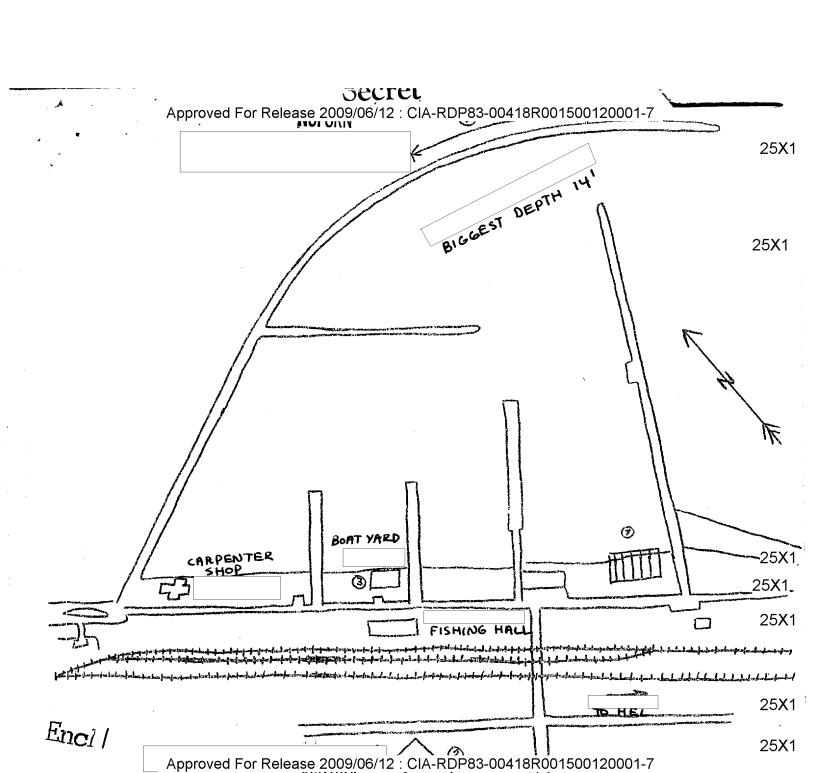
## Explanation of the Drawing 2.

harbor transverse slip for vessels of an estimated 500 tons has been built. The fish industry facilities have grown and improved. Otherwise the harbor has not changed much; there are no special new buildings. The war damages have been repaired. There were more than one hundred fishing vessels in the harbor. No naval vessels.

- New transvery slip for repairs of fishing vessels. l.
- New fishing industry building in two floors. 2. floor there is housing for the factory workers. building is not completely finished.
- Small boat yard. Only the smallest fishing boats can be 3. built here.
- The mole repaired on this piece. 4.
